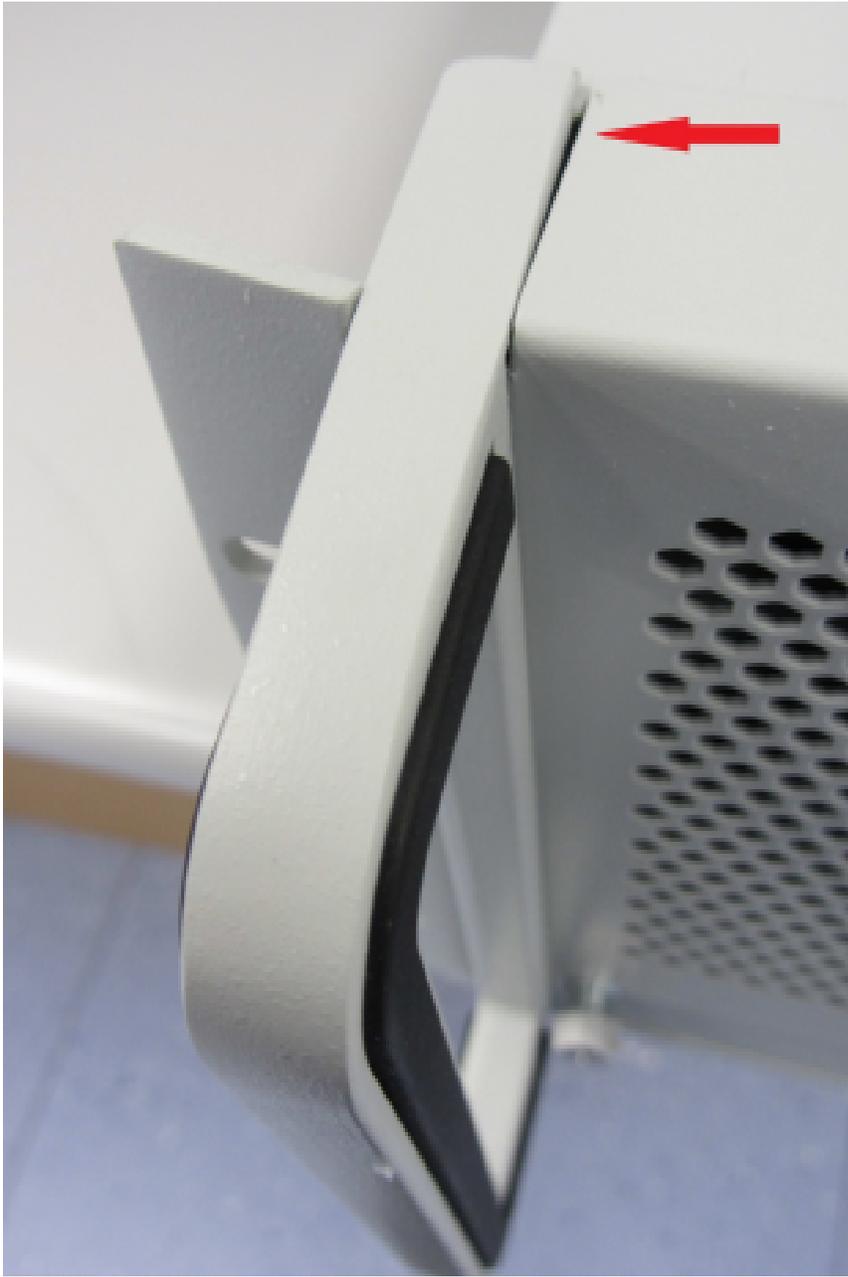
Figure 4: Bended handle left side

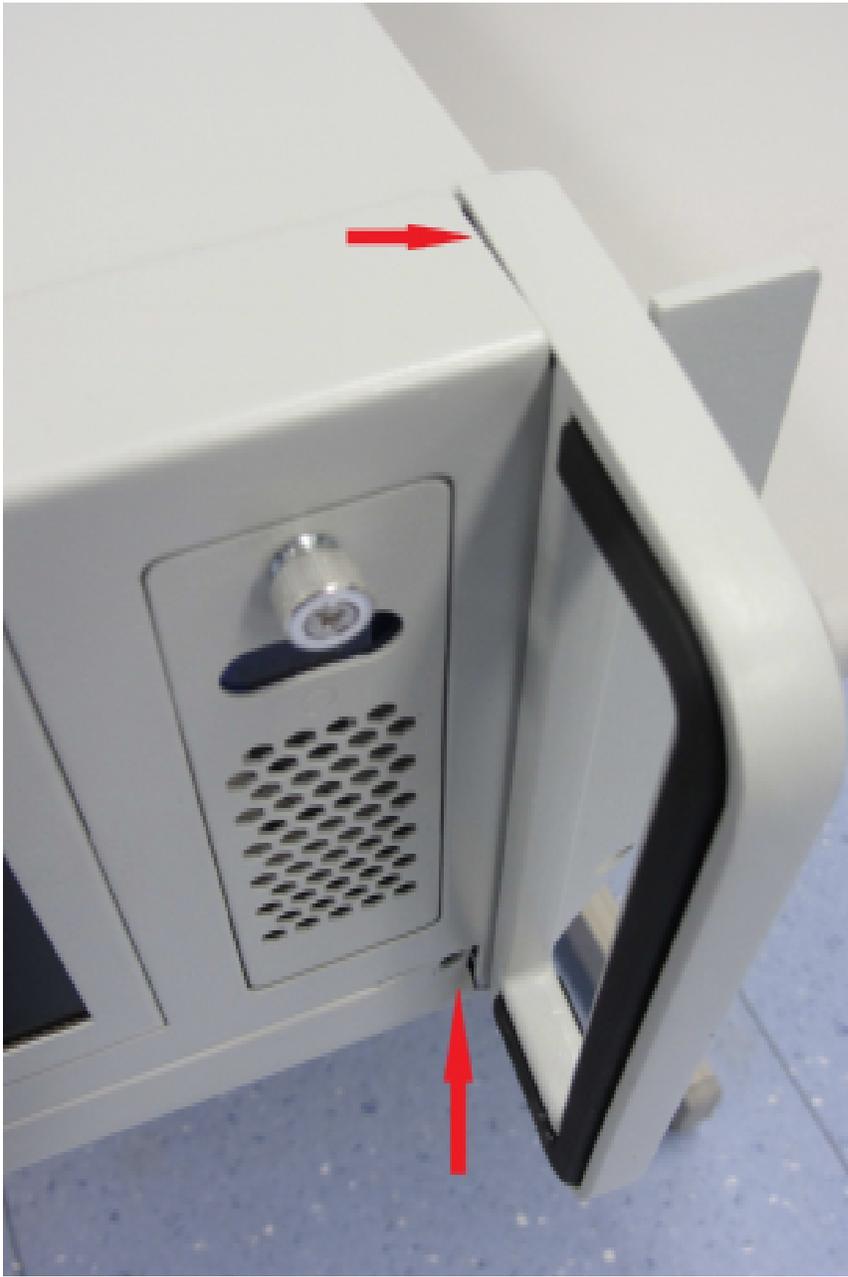
Figure 5: Bended handle right side and missing telescopic KBD/MS pad lock

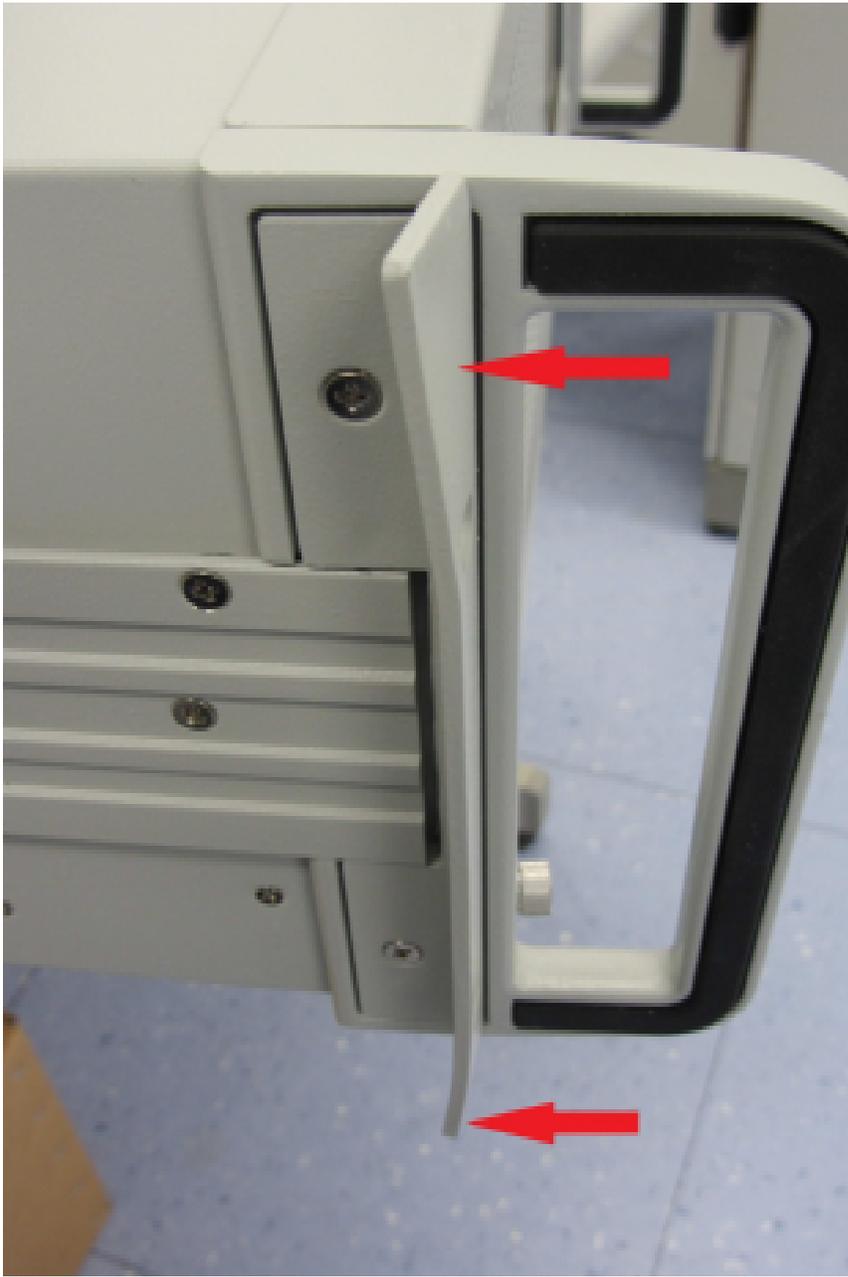
Figure 6: Bended rack mount flange left side

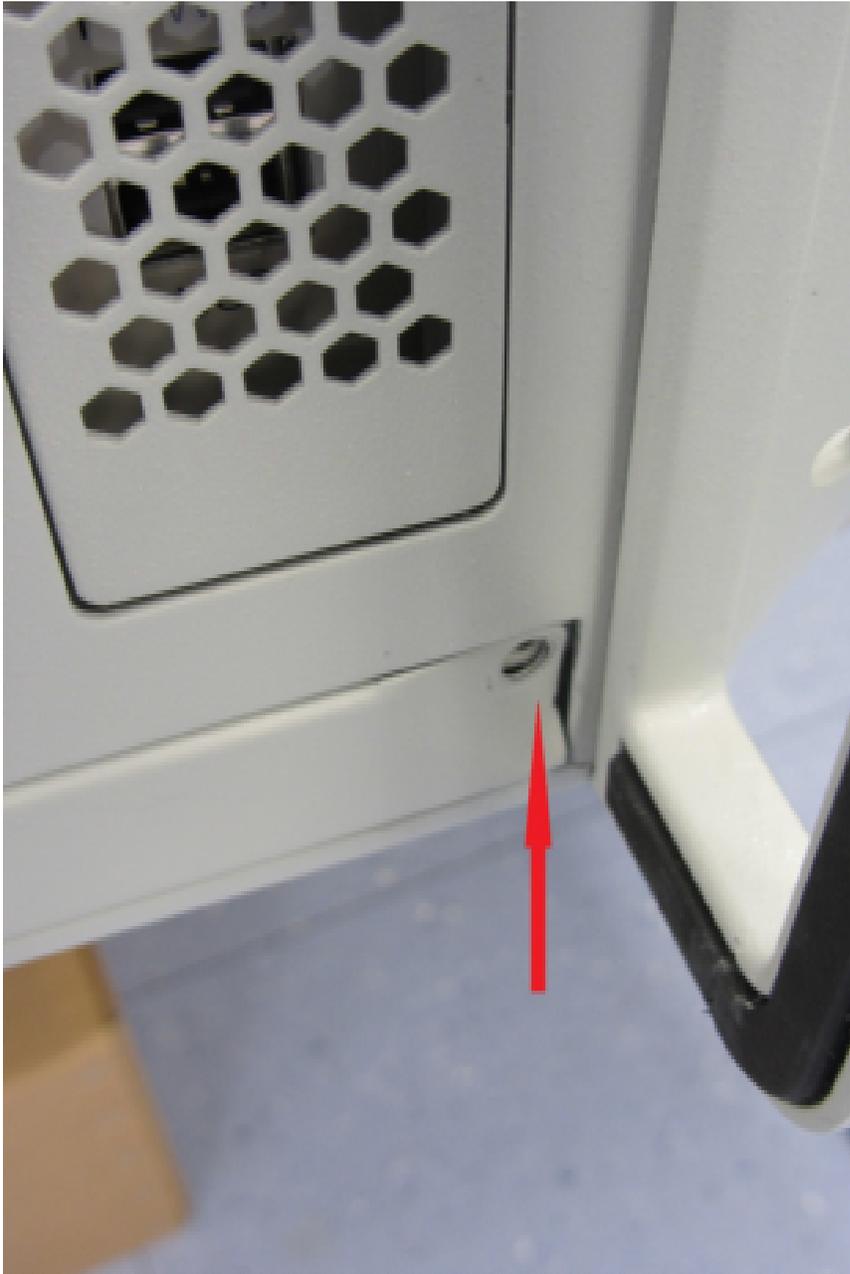
Figure 9: Missing telescopic KBD/MS pad lock + dent

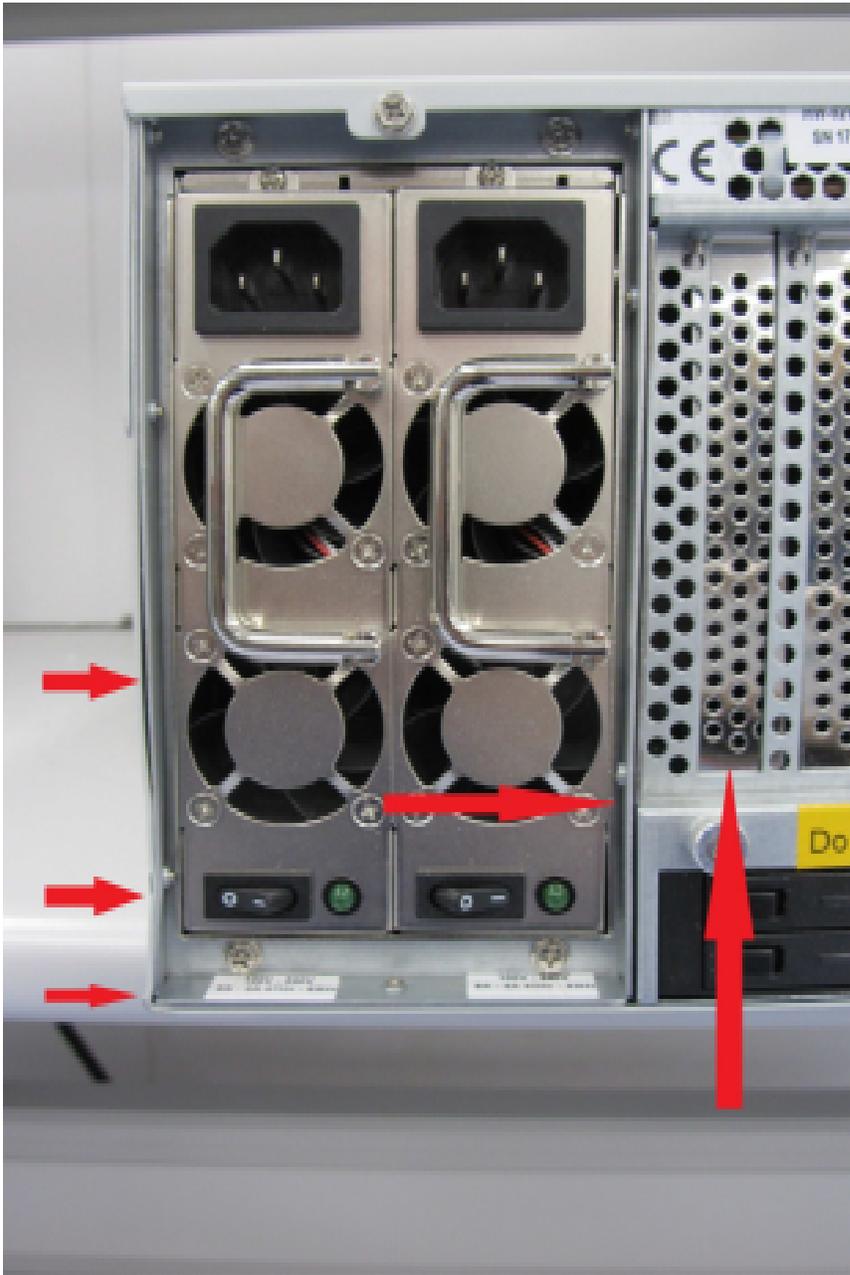
Figure 10: Bended rear frame & misalignment of PCI slots

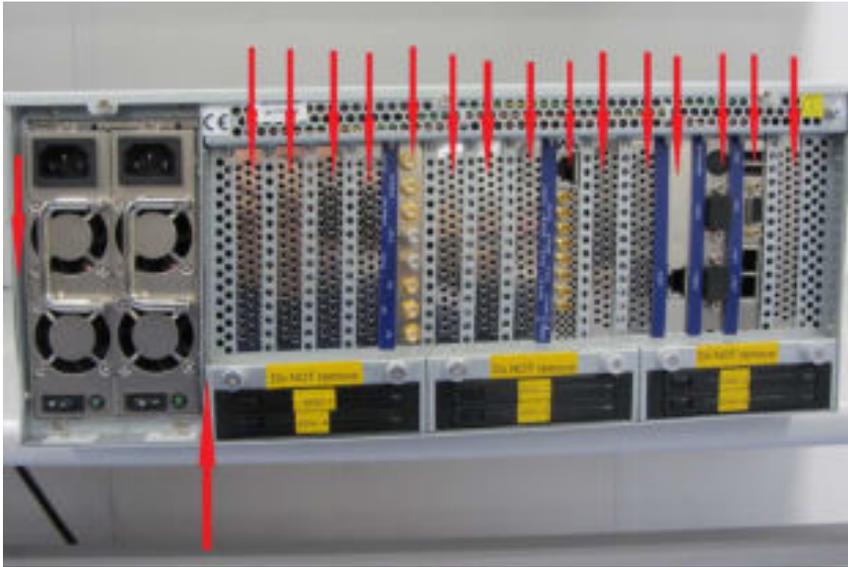
Figure 11: Bended rear frame & misalignment of PCI slots

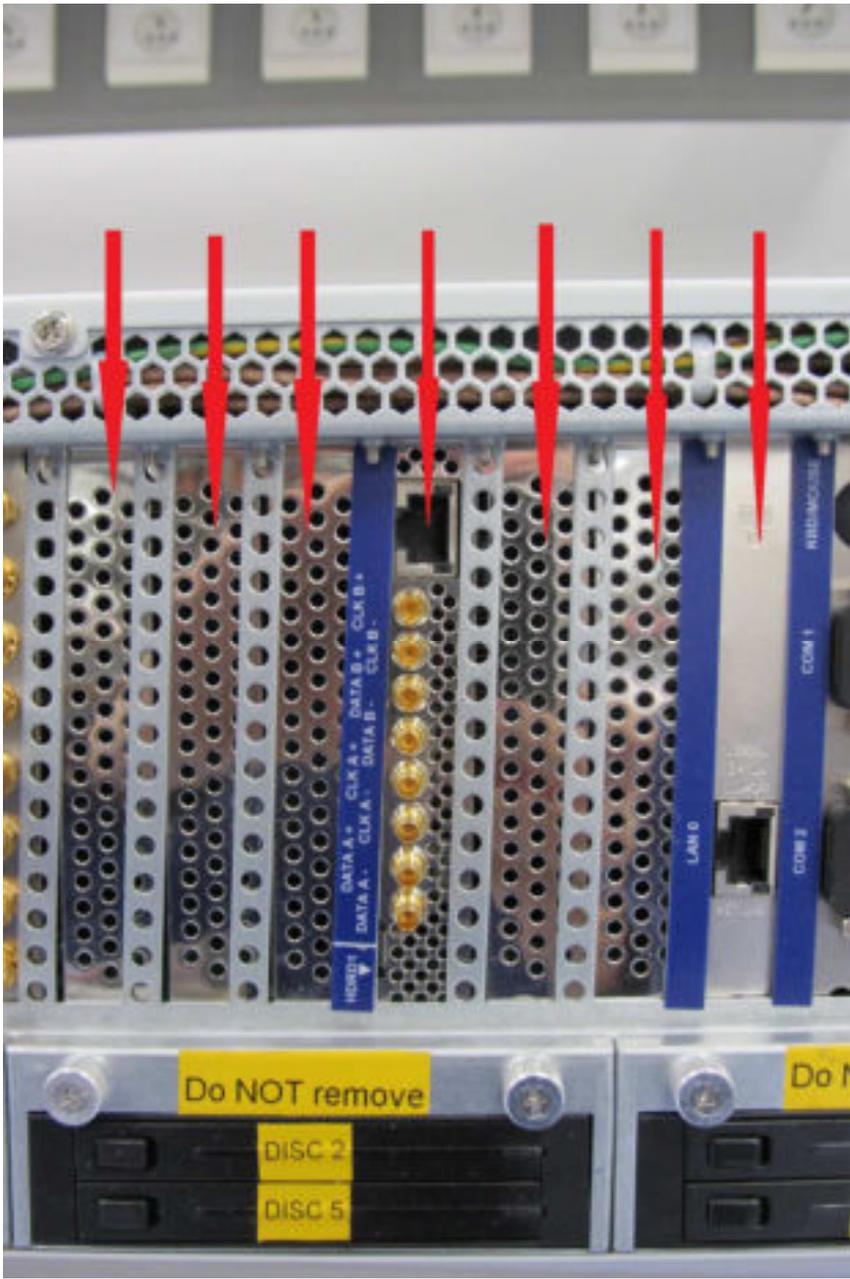
Figure 14: Misalignment of PCI slots

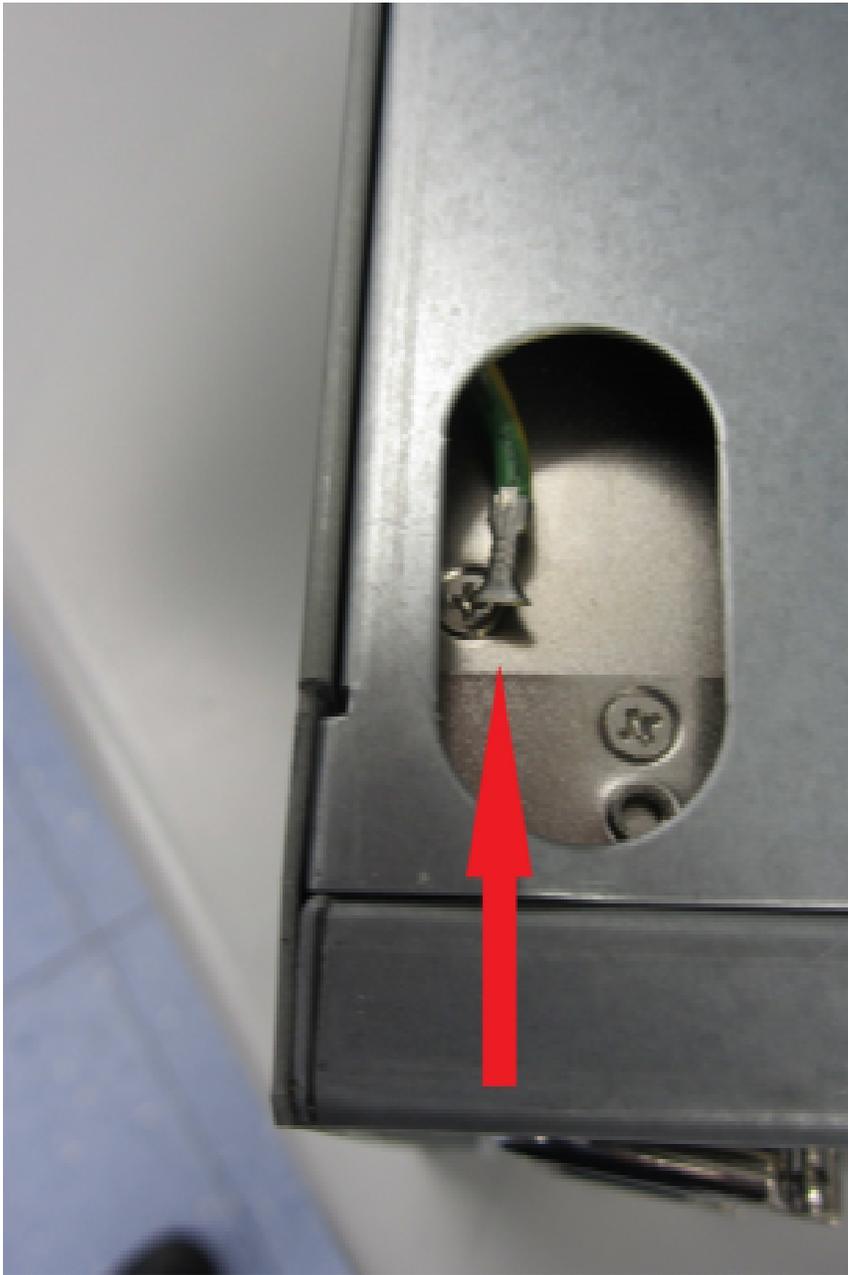
Figure 16: Broken safety earth connection

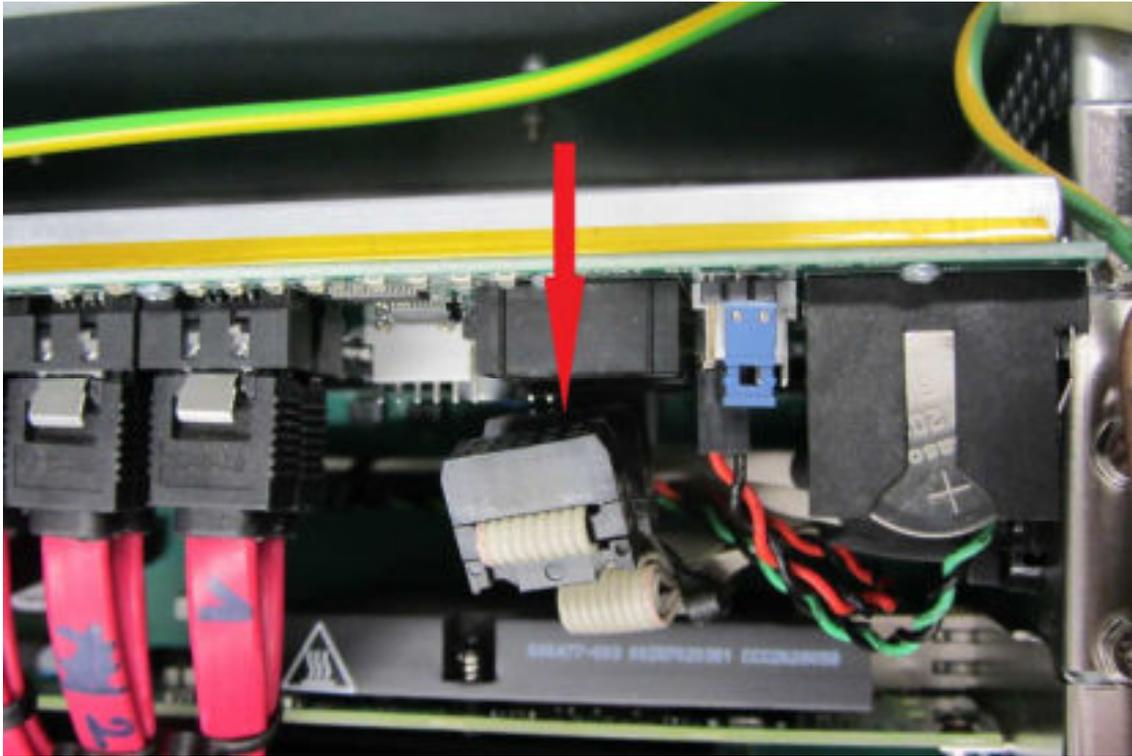
Figure 17: Disconnected COM1 & COM2 flat cable connectors

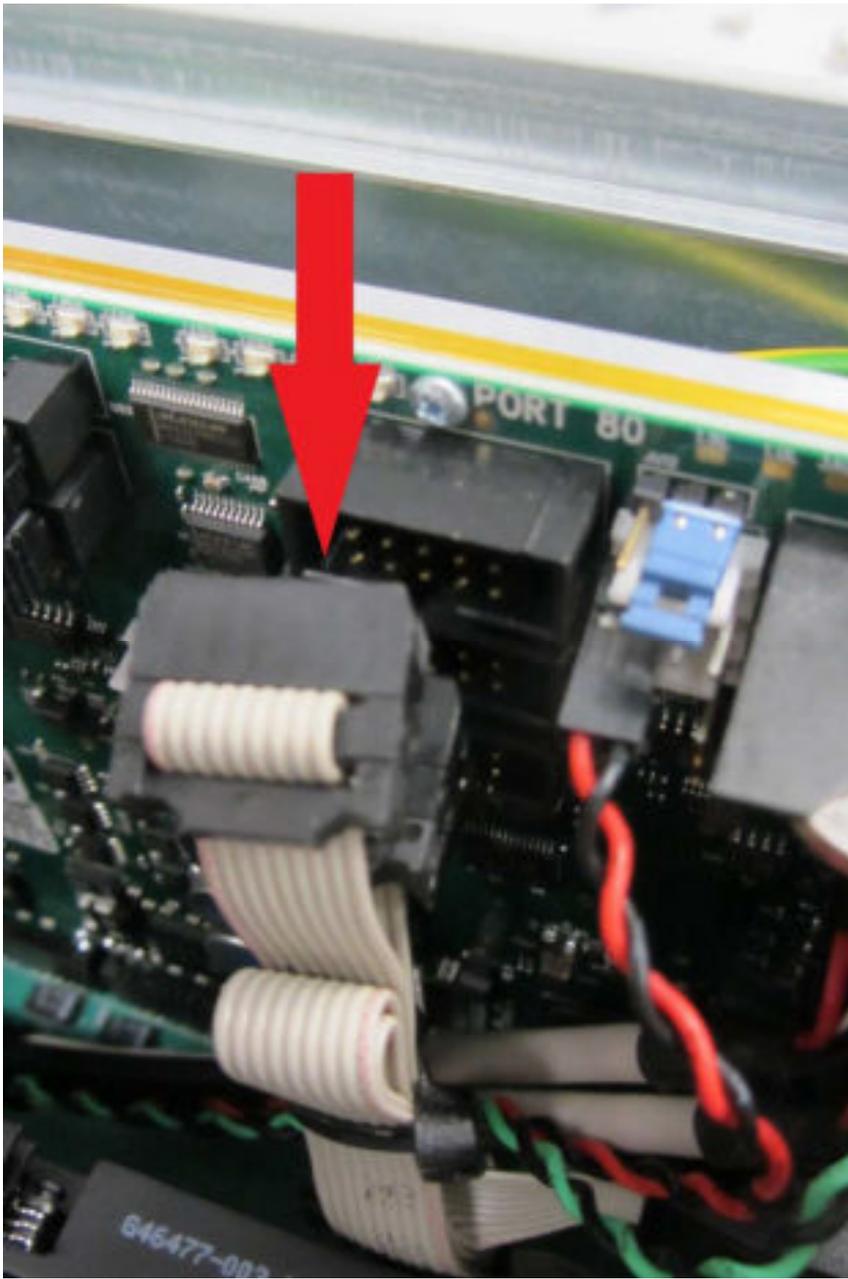
Figure 18: Disconnected COM1 & COM2 flat cable connectors

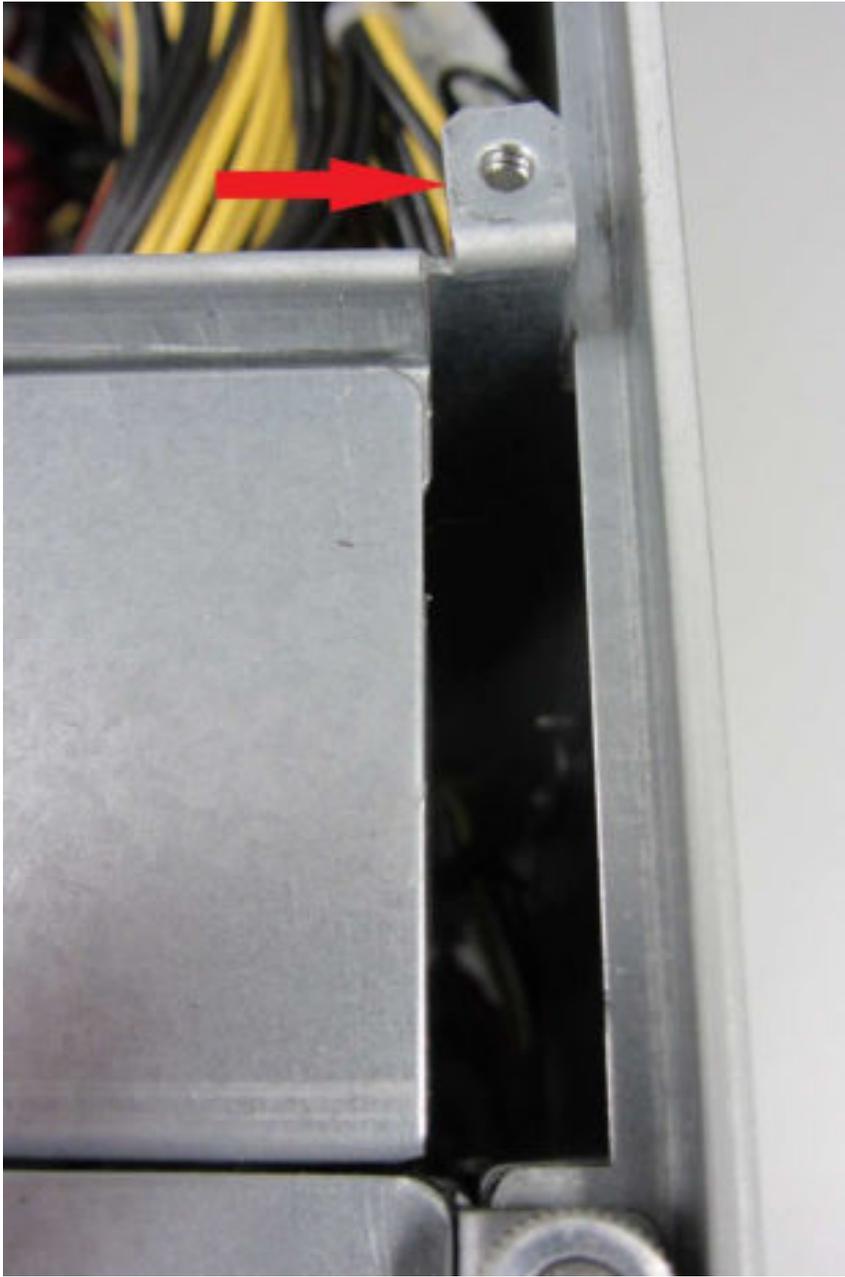
Figure 20: Misalignment of right internal top cover fixation

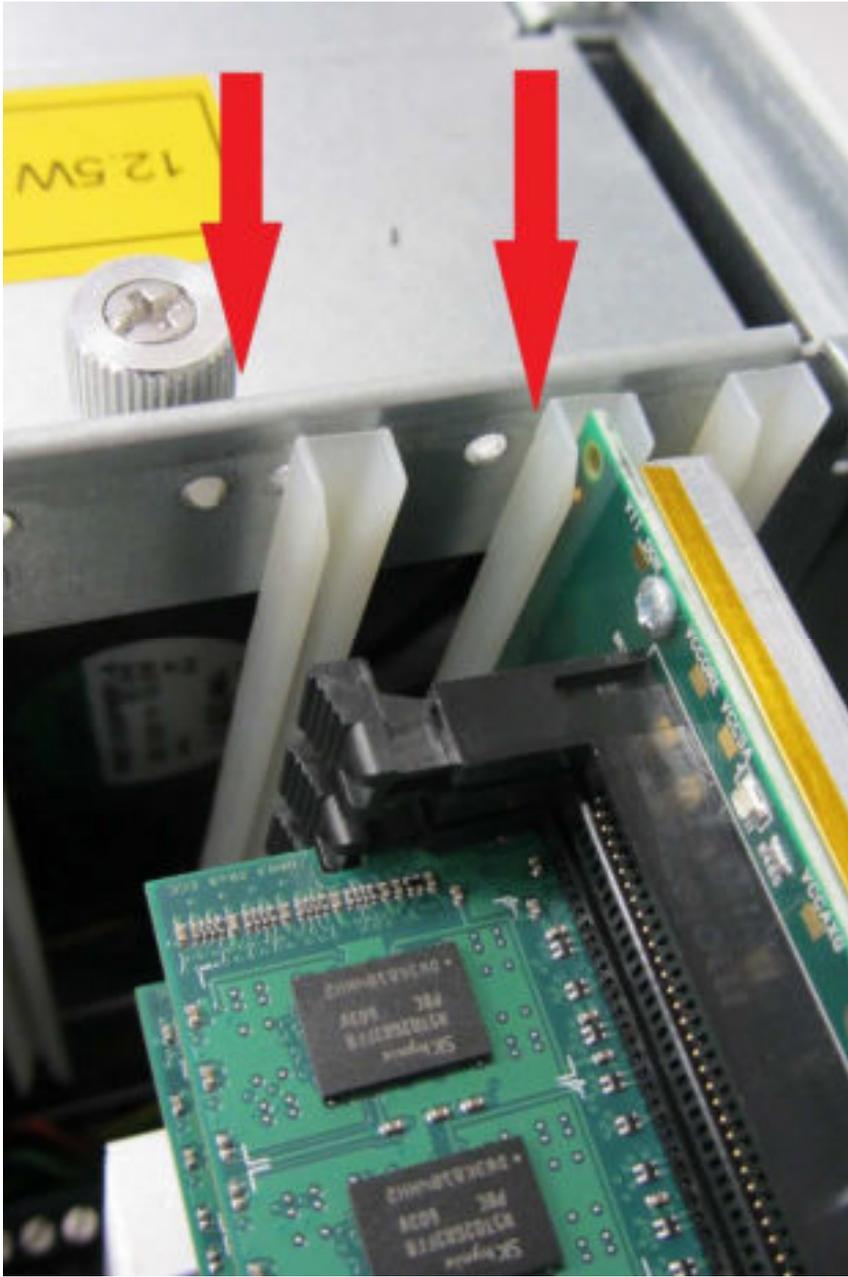
Figure 21: Damaged card slide fixation on processor board

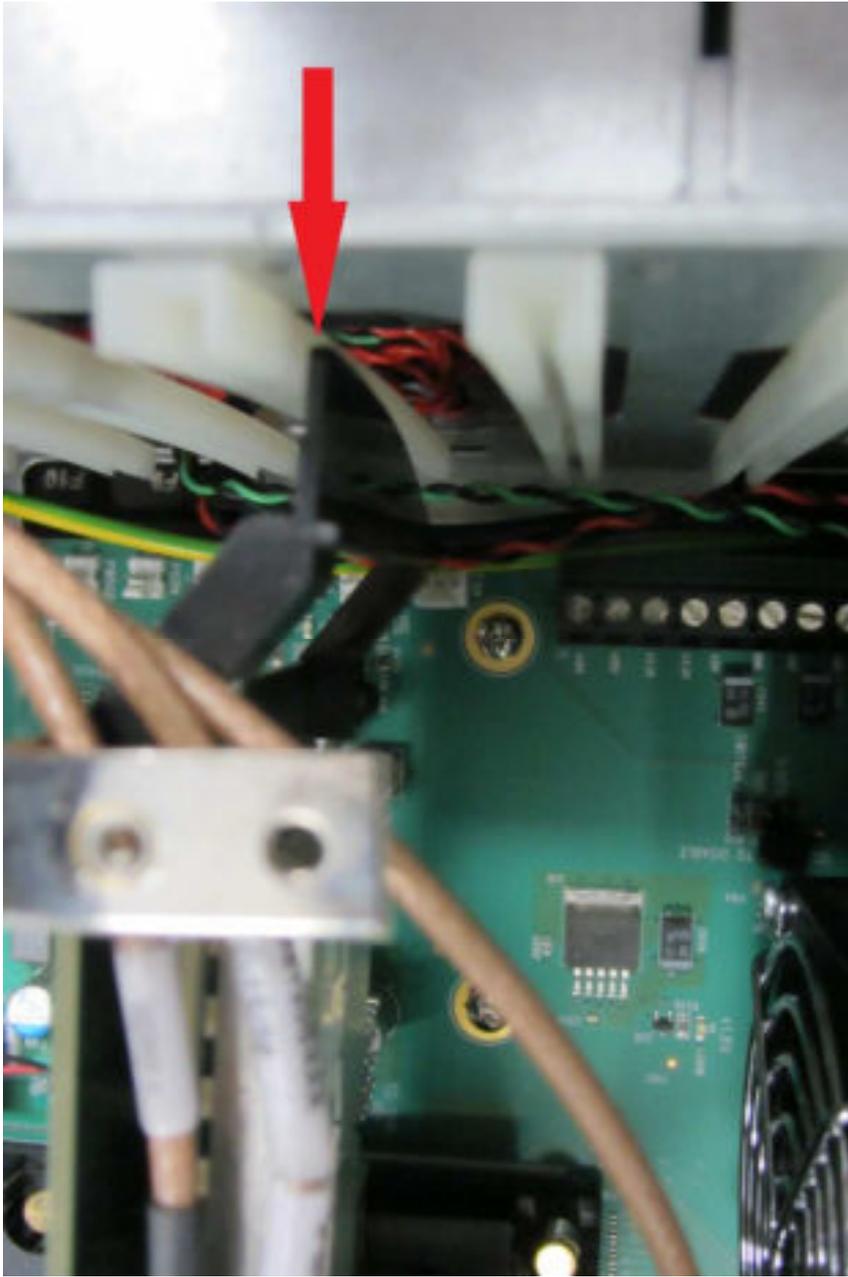
Figure 23: Misalignment of HDRD board aside its card slide

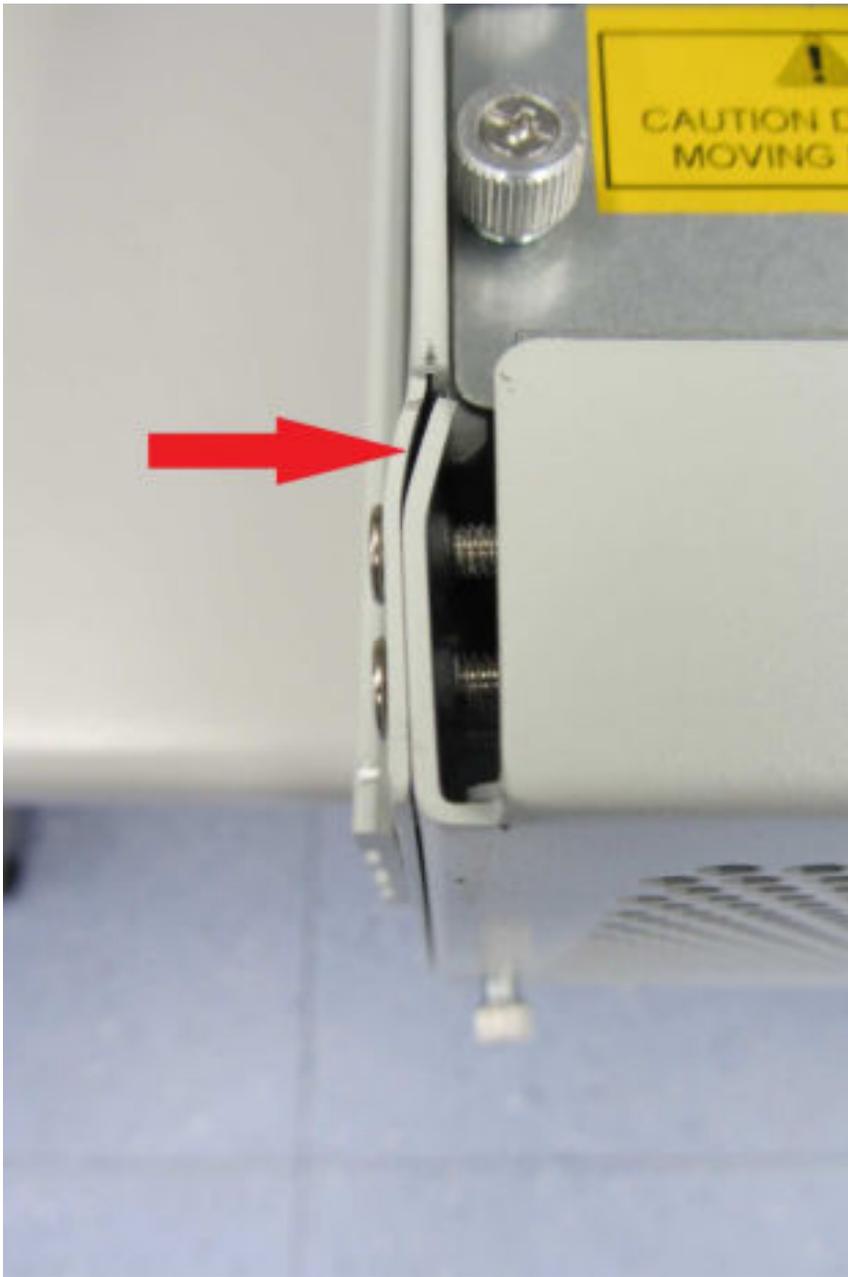
Figure 24: Bended front panel left side

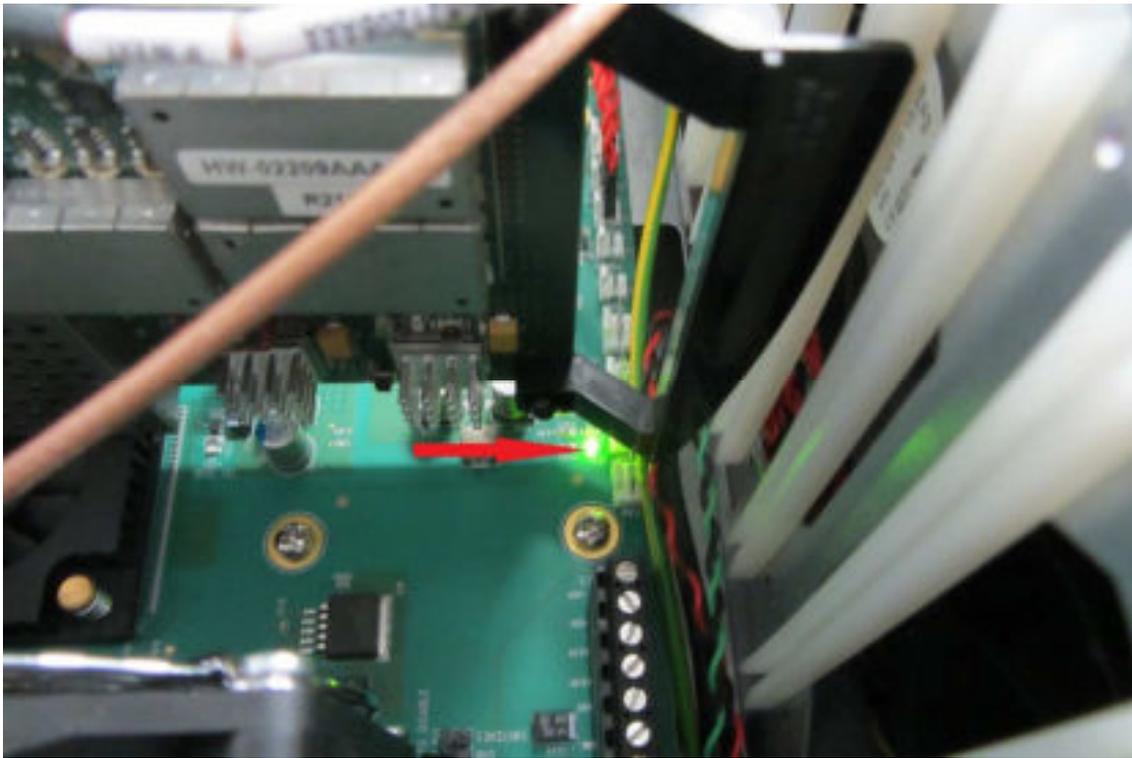
Figure 25: Illuminated stand-by LED

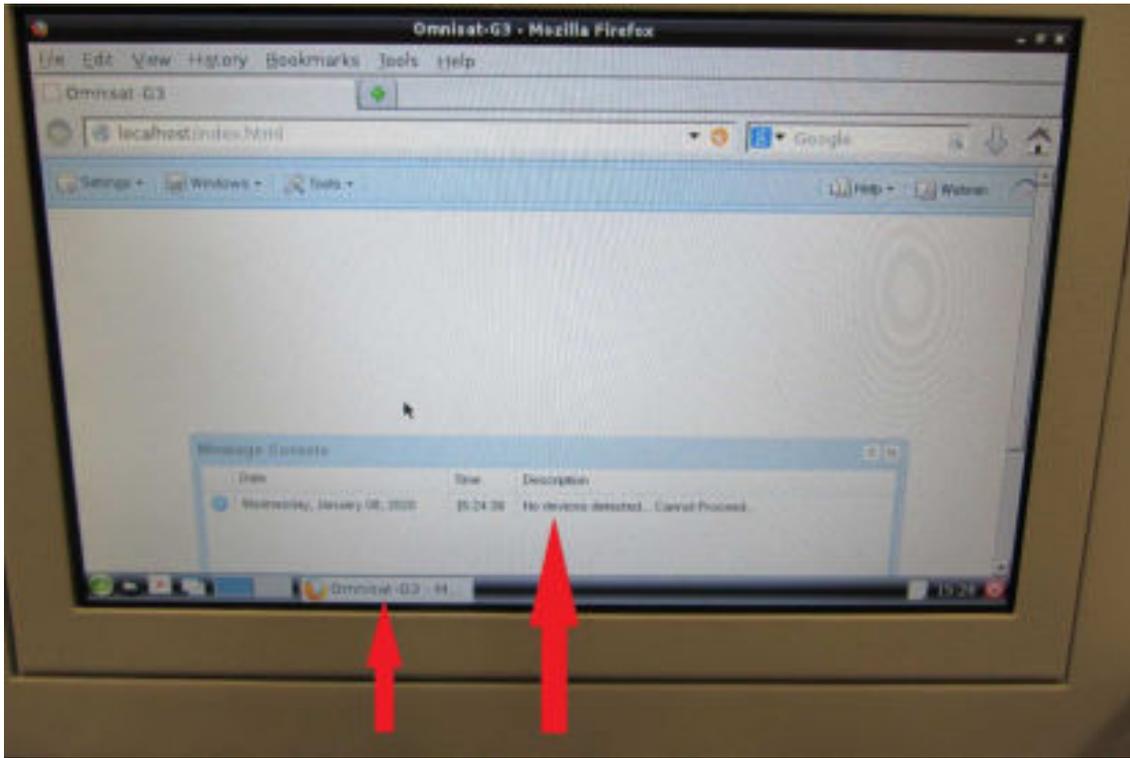
Figure 28: Error message after booting process
