... the carrying vehicle was involved in a transport accident on the motorway. According to the information available, the carrying vehicle had collided with a commercial vehicle at the end of a traffic jam.

The cargo consisted of stainless-steel pipes of grade TP316LM/1.4404, length 6,096 mm, diameter 79.38 mm x 2 mm. There was a total of 24 bundles of 20 pipes each. The total weight was 11,352.72 kg net/12,792.72 kg gross.

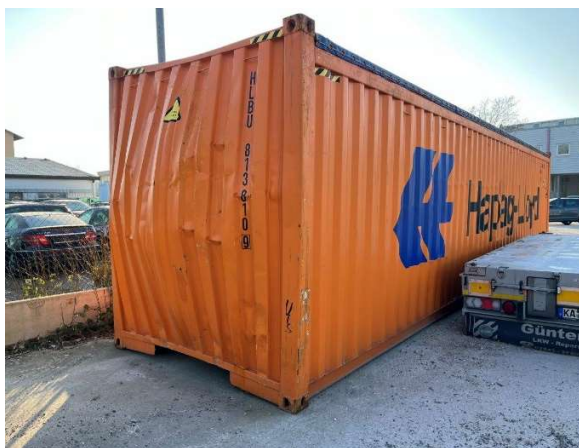
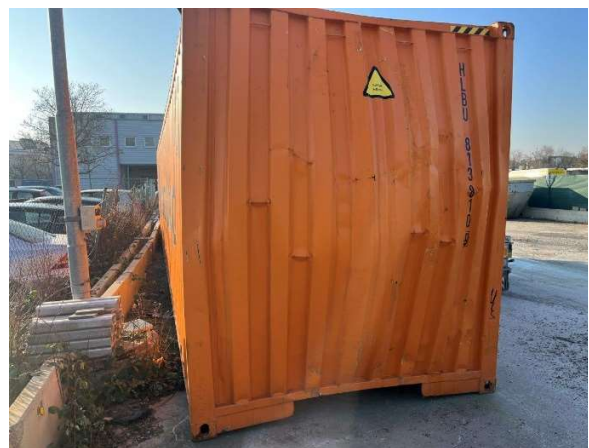
The container was presented at the salvage company's outdoor storage area in Karlsruhe. The open-top container showed external damage to the front wall, which was massively dented. The right-side vertical post was deformed.

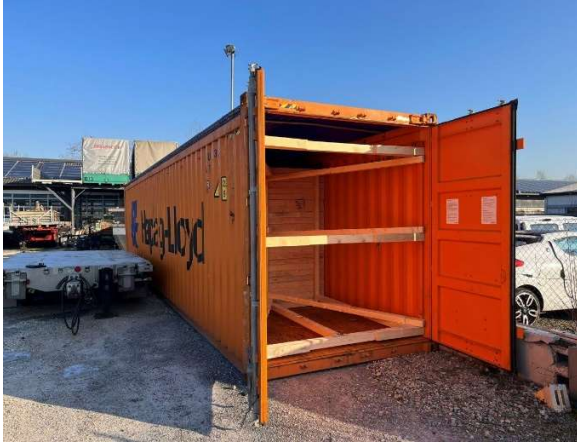
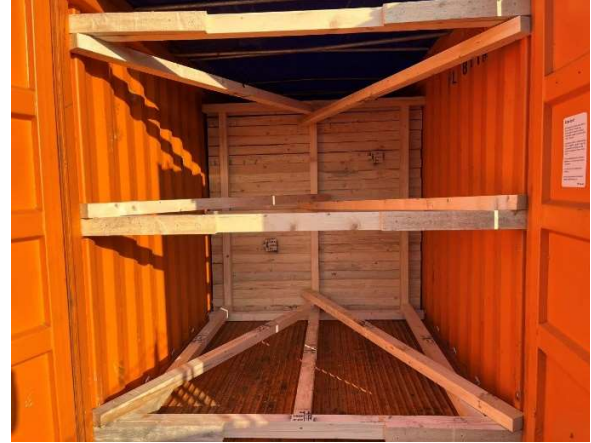
After the rear door was opened, it could be seen that the wooden bracing in the rear was still in place and apparently undamaged.

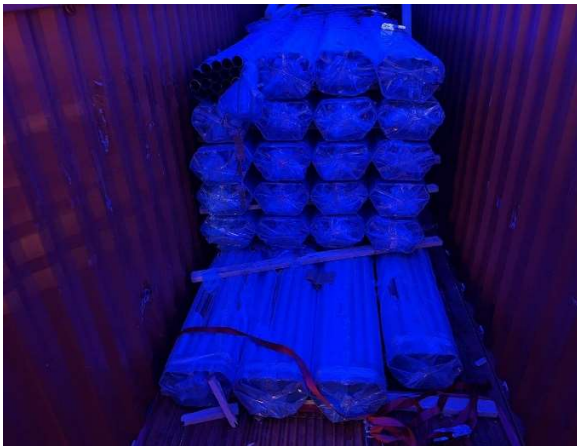
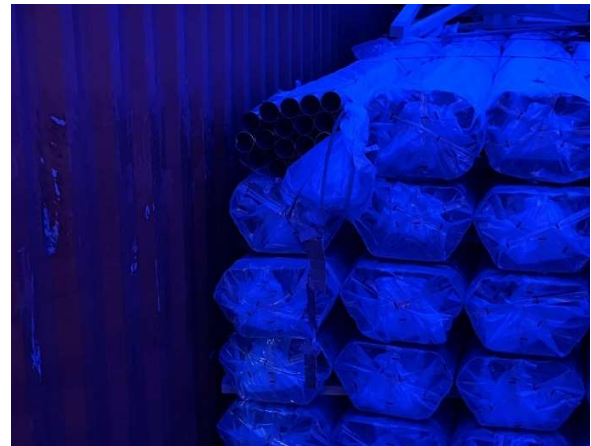
The load could be inspected via the wooden wall. It was seen that the bundles of tubes were stowed five layers high with four bundles per layer. Timber had been used as intermediate layers and had been lashed down with belts over the top layer.

The bottom layer had shifted and was about 175 cm away from the securing at the rear. The top layers had shifted a further 120 cm towards the front wall.

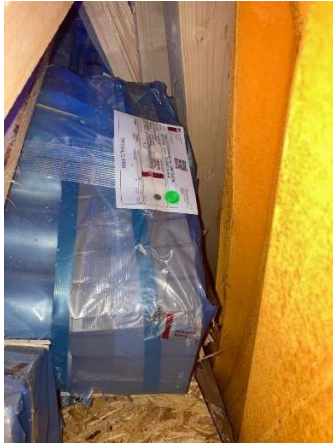
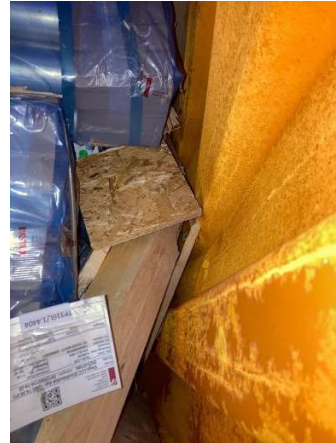
The tubes on the sides were obviously in contact with the wall. The film was open on one bundle, and a laterally deformed tube was visible.

The tube bundles, which had shifted towards the front wall of the container, had penetrated a front-side load-securing device in the form of a wooden wall, similar to the rear-side securing device. The top five layers had slipped right up to the front wall.

Further lateral deformations, longitudinal distortion and deformations on the front ends, in particular the front ends at the front of the pipes, cannot be ruled out. Scratches may also have been incurred on the outside of the pipes due to the shifting.
