Photo documentation regarding the transport damage AVR (Automatic Voltage Regulator) Sterostab Y314AP80 , cod. 07725083, s/n 747575. Erwin Junker

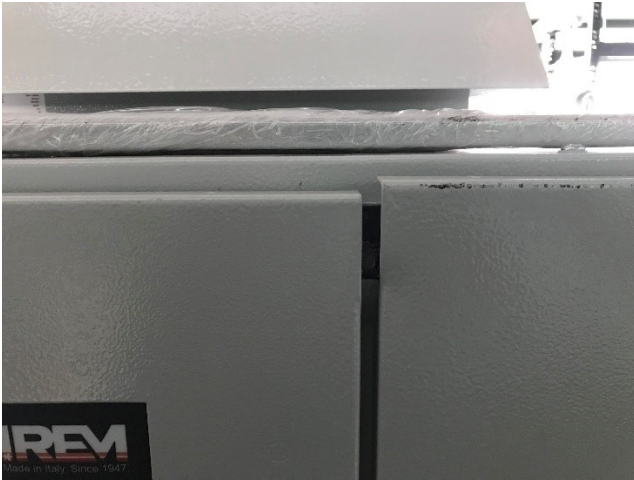
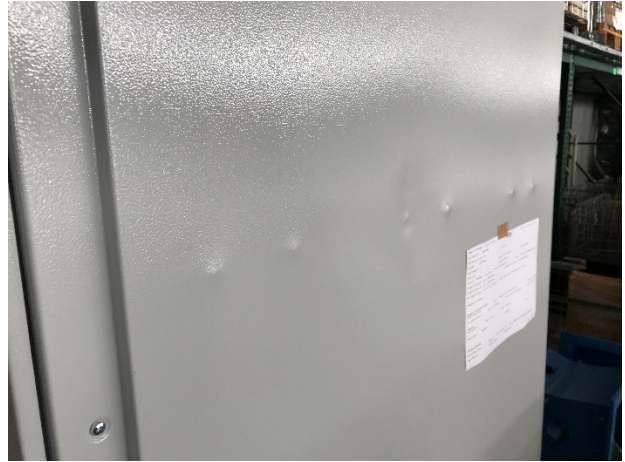
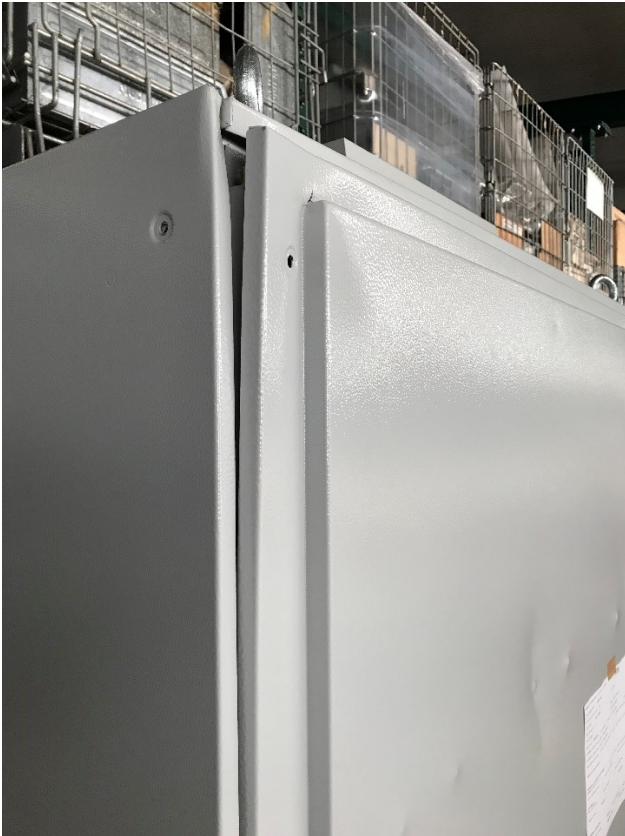
Outside panels of the AVR are damaged and have to be replaced:

- Parete post. (back side)
- Fiancata (side panel)
- Coperchio (top closure)
- Porta SX (left door)
- Porta DX (right door)

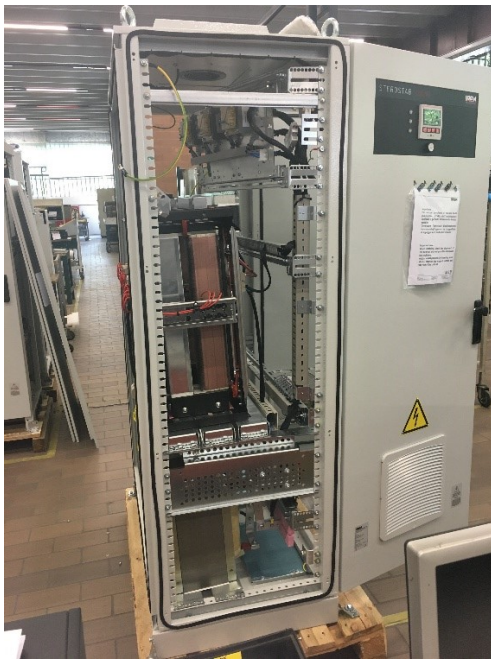
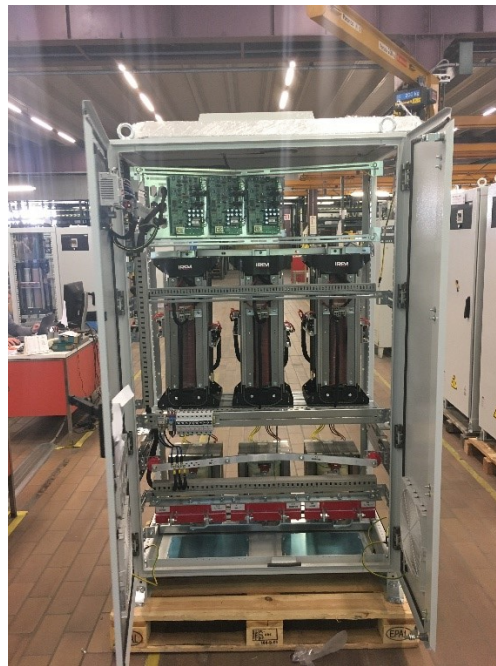
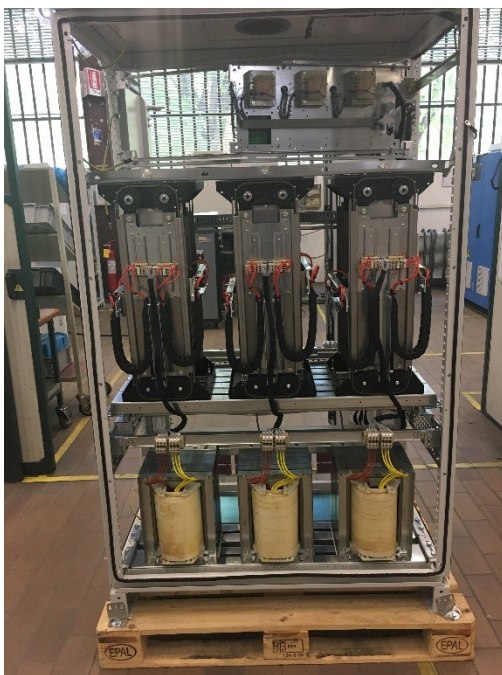
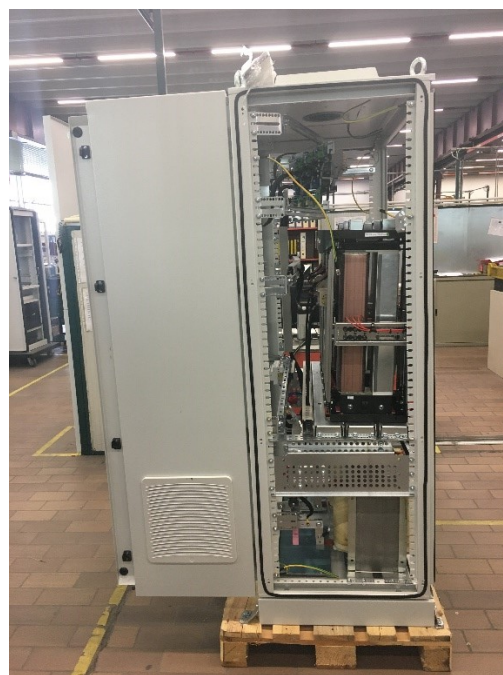
The structure of the item is badly bent and has to be replaced:

- Traversa front (front crossbar)
- Telaio saldato (welded frame)
- Piede telaio (frame support)
- Fondo (bottom plate)

Vital electrical components are damaged and out of order

- Regolatore (autotransformer, including motor and carbon brushes)
- Scheda (electronic board)
